# Removal and Replacement of Failed Bonded Nutplates Utilizing Nonmetallic Torlon® Adhesive Cutters

**24 May 2018**

**Brett Bolan  
Paul Childers\*  
Jim Mazza  
AFRL/RXSA**

**Systems Support Division  
Materials & Manufacturing Directorate  
Air Force Research Laboratory**

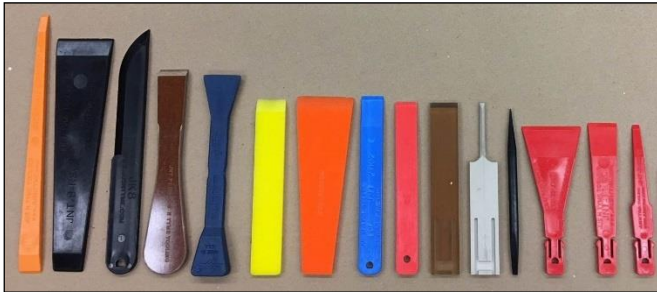
Current T.O. authorized plastic removal tools

- did not adequately perform function
- time consuming

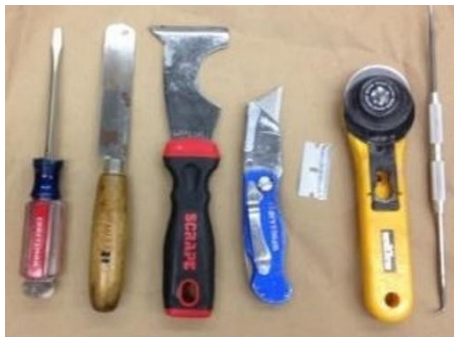
Use of non-authorized metallic removal tools

- removed sealant/adhesive quickly
- high potential to damage structure  
scratches and gouges – extensive rework

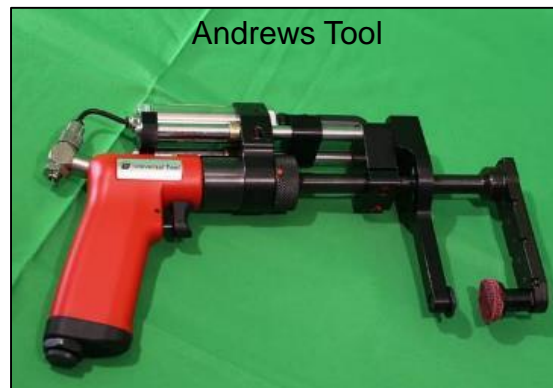
Norton Vortex  
Medium Pad

Using a 3200 rpm pneumatic rotary tool with an abrasive pad to remove sealant/adhesive – heat generated causes sealant/adhesive to smear on faying surface and rapidly clogs pads

- 10 or more pads required to achieve clean surface
- access limited by throat depth
- cannot be used on composites

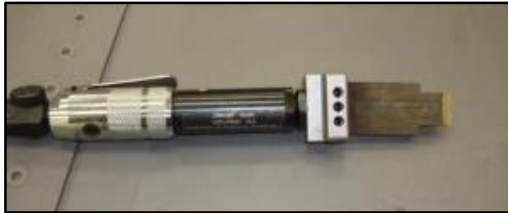
Attach 5030 glass-filled Torlon blade to a pneumatic driven tool to remove adhesive from a composite panel

Easily removes adhesive with no visible damage to underlying structure

Field trials demonstrated inability to access many locations due to tools bulkiness  
- does not meet “accessibility” requirement

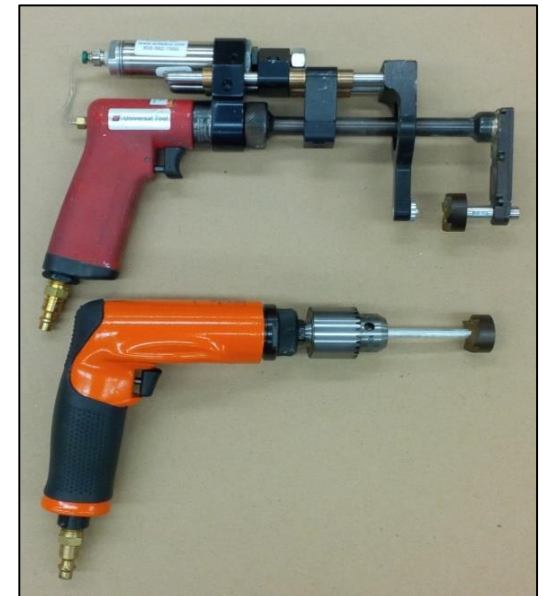
Test concept – 3D printed 2 most prevalent sizes for nutplates - assessed form and fit

Transition into fabricating/machining from Torlon 5030 to fit both Andrews Tool and drill motor

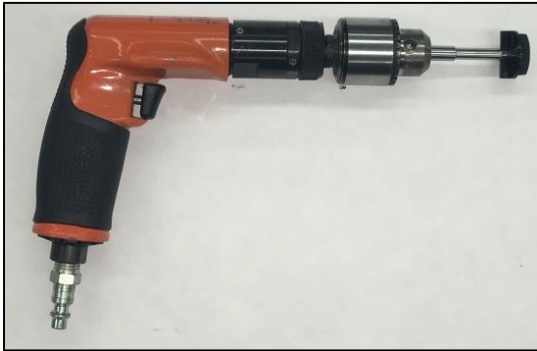
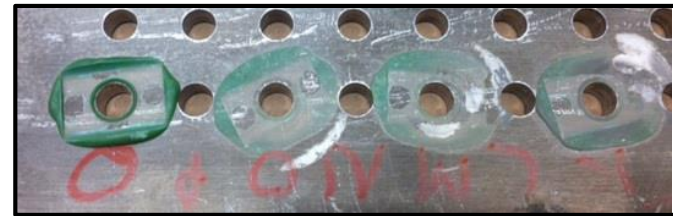
Effectively and quickly removed (in a min or less) remnant adhesive on aluminum substructure when attached to a 1400 rpm drill motor

Thin blades – 1.91mm (0.075")  
Blade draft – 3.8mm (0.15") deep

Blade edges worn away due to combination of adhesive's hardness and rotational speed of drill motor

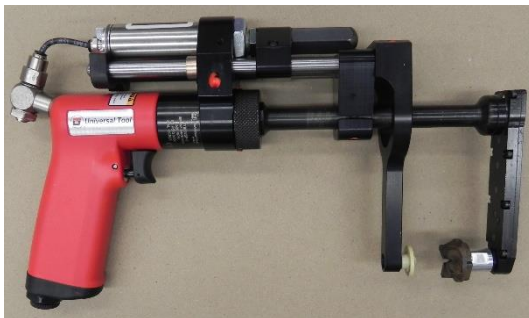
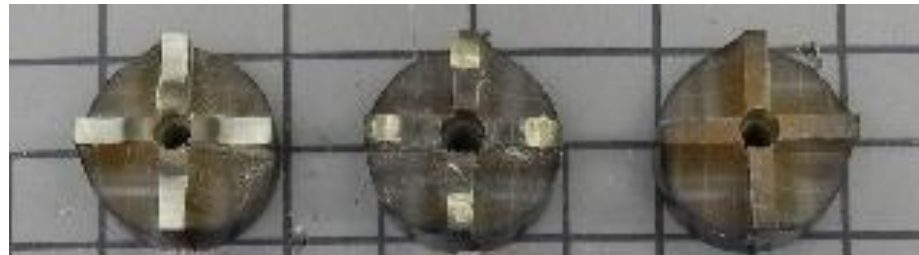
Focusing in on lower-speed models of tools  
Andrews Tool company provided 3200, 1000, and 500 rpm tools for evaluation

@ 3200 rpm – notching  
@ 1000 rpm – slight notching  
@ 500 rpm – no observed damage/wear to cutter

Selected 500 rpm Andrews Tool & 600 rpm DOTCO Drill

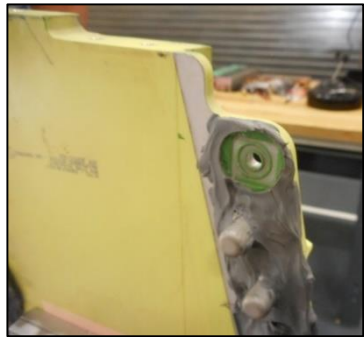
Representative aircraft structure  
Failed nutplate location with  
sealant and adhesive

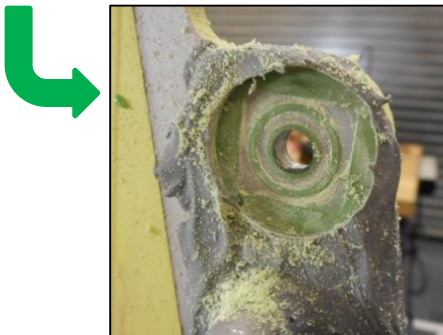
After one min – sealant  
removed and only a  
“ghosting” of adhesive  
remaining

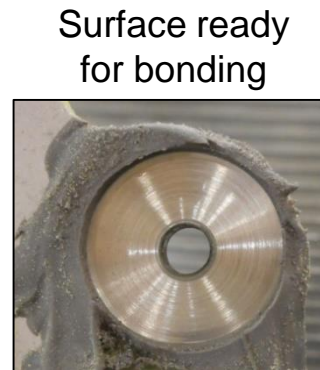
Surface ready  
for bonding

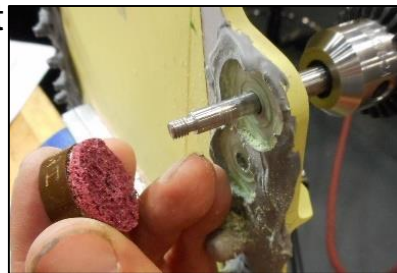
Abrasive pad for  
final preparation

In less < 2 min gone  
from failed nutplate to  
structure ready for  
bonding  
- Following T.O.  
procedure would have  
taken 10's of min

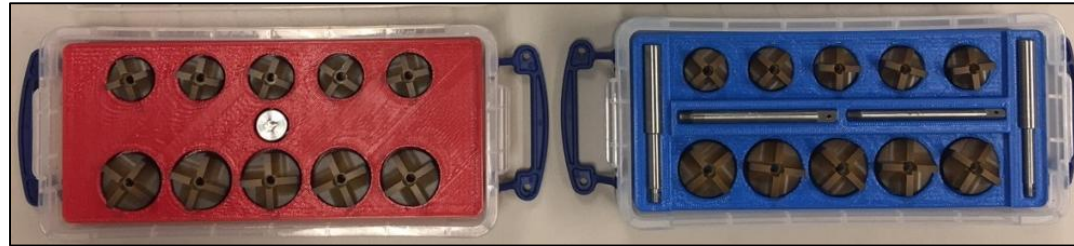
Beta kits of Torlon cutters, mandrels, and Andrews Tool Adapter

Sent to Operational units for several months of Evaluation/Field Trials

- very positive feedback – significantly reduced time for preparing structure for bonding
- found/discovered new requirements
  - additional size cutter desired – 33mm (1.3”) diameter for hard to access locations
  - difficult to remove Torlon cutters from tools
    - redesigned cutter to have a flat zone on its backside - engage with a wrench

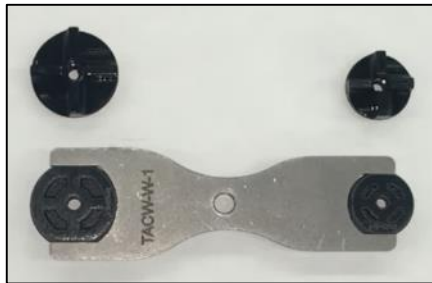
Prototyped a wrench – field trials discovered another requirement  
- wrench needs to engage with Andrews Tool adapter

Created new prototype – field trial – customer approved new design

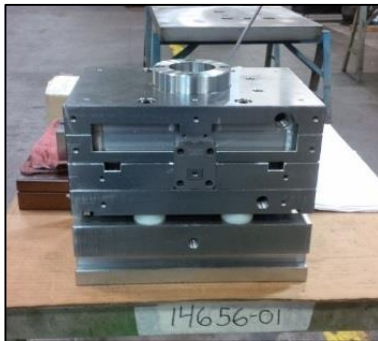
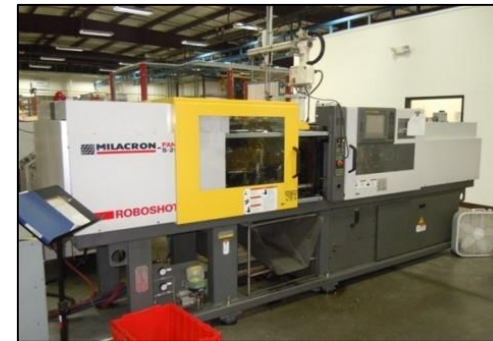
UDRI worked with AFC Tool Company – design of cutters for injection molding

Performance Plastics Ltd (PPL) for fabrication of injection mold tool & injection molding cutters

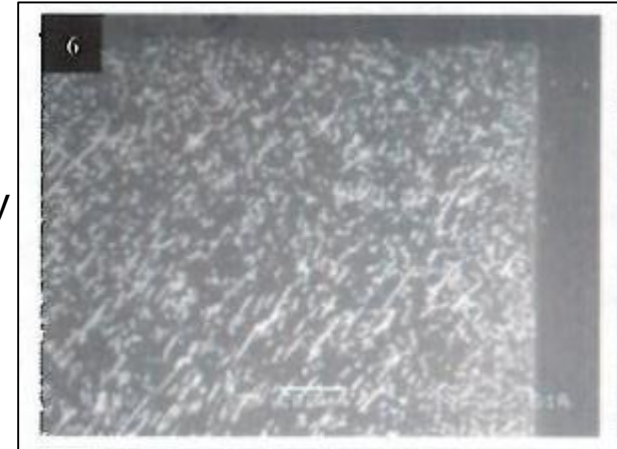
Focusing on cutter's edge saw  
only 2% increase in fiber density  
for injection molded cutter

Injection molded cutters  
Fibers have more random orientation

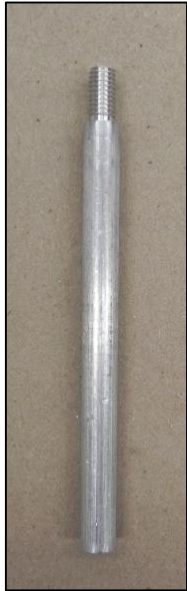
## 1<sup>st</sup> iteration

6061 Al standard mandrel  
galling observed –  
potential damage to hole

4140 steel – shoulder added  
due to concern with FOD  
Several months in humid  
environment – pitting corrosion  
OEM concerned could cause  
damage to hole

17-4 PH SS  
H-1000 condition  
Similar UTS but much  
higher corrosion resistance  
No observed corrosion after  
months of testing

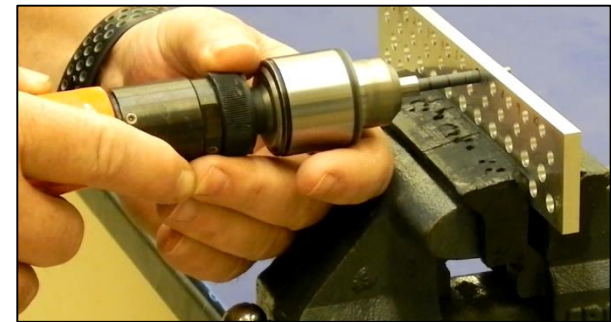
mandrel "resting" in the hole

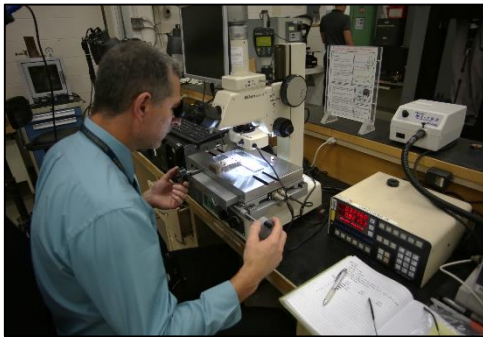
3x Optical Microscope – topside hole

- No damage created with or without coating on mandrel
- No damage to backside of aluminum structure despite aggressiveness with cutters

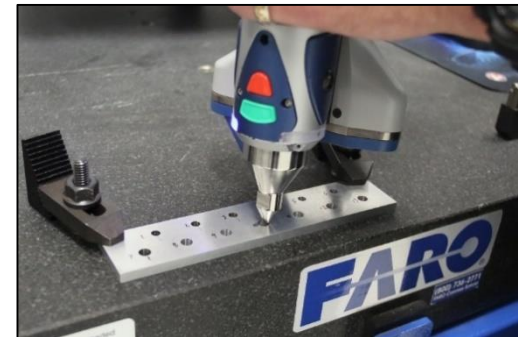
FaroArm - inside hole

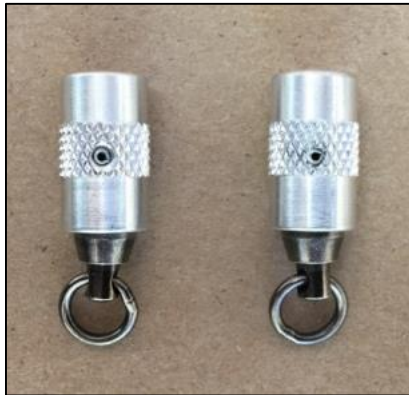
Updated swivel connector

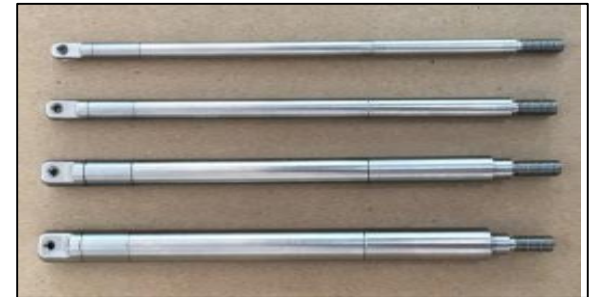
Segmented mandrels – different diameters

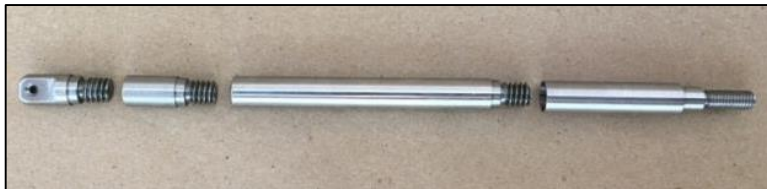
Segmented tetherable mandrel broken into a tether mounting hole (a), and a 12.7mm (0.5") (b), a 63.5 (2.50"), a 38.1 (1.50") segments

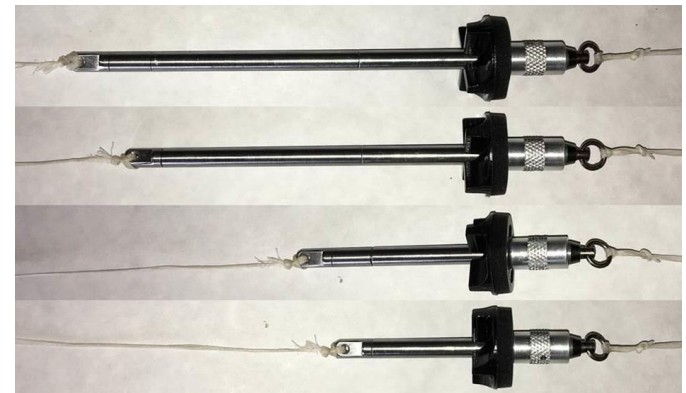
Segmented tetherable mandrels with Torlon cutters & tethers
